## HST SM-3B

Hingepin Survey
MLI Survey
Reboost HST Motion Analysis

David R. Bretz
Image Science and Analysis Group
JSC/SX3

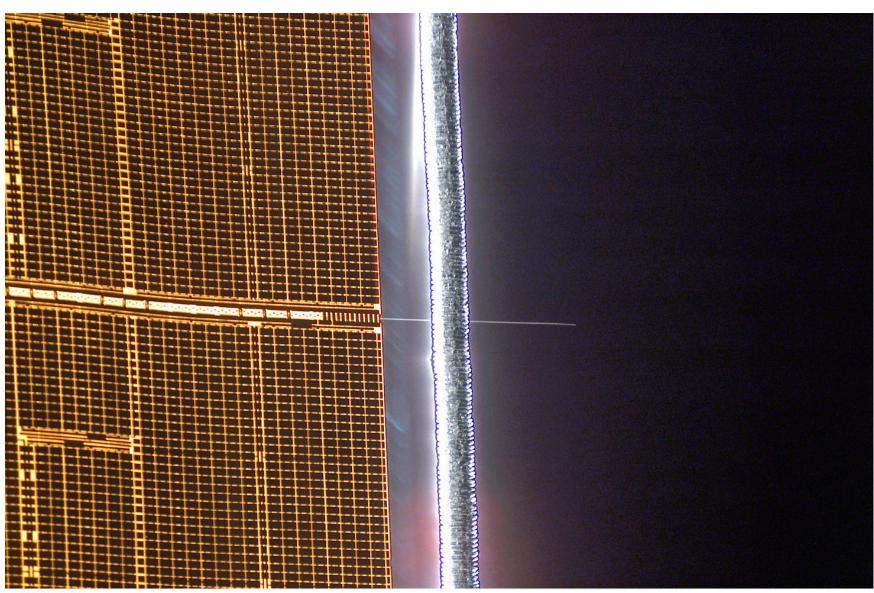
+V2 Pin Closeup (+DD/+CC, 21.3 inches)

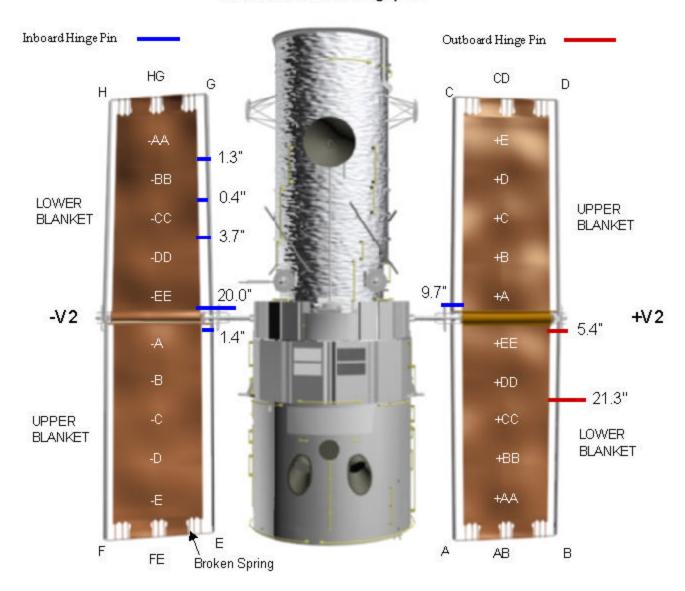
#### STS-109 SM-3B Hingepins

STS-109/ SM-3B							
-V2			+V2				
SPAs	Outboard	Inboard	SPAs	Inboard	Outboard		
OBA GH /-AA	no pin	no pin	OBA CD / +E	no pin	no pin		
-AA / -BB	no pin	1.3	+E / +D	no pin	no pin		
-BB/-CC	no pin	0.4	+D / +C	no pin	no pin		
-CC/-DD	no pin	3.7	+C / +B	no pin	no pin		
-DD/-EE	no pin	no image	+B / +A	no pin	no pin		
-EE / IBA	no pin	20.0	+A / IBA*	9.7	no pin		
IBA/-A	no pin	1.4	IBA / +EE*	no pin	5.4		
-A / -B	no pin	no pin	+EE/+DD	no pin	no pin		
-B / -C	no pin	no pin	+DD/+CC	no pin	21.3		
-C / -D	no pin	no pin	+CC / +BB	no pin	no pin		
-D/-E	no pin	no pin	+BB / +AA	no pin	no pin		
-E / OBA EF no pir		no pin	+AA / OBA AB	no pin	no pin		
All measurements are		2.712	o this is a minimum leng

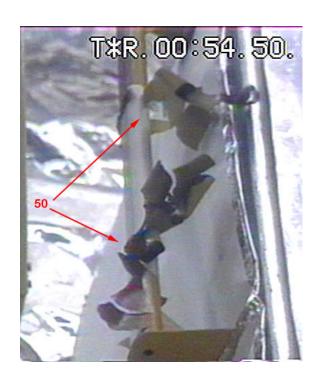
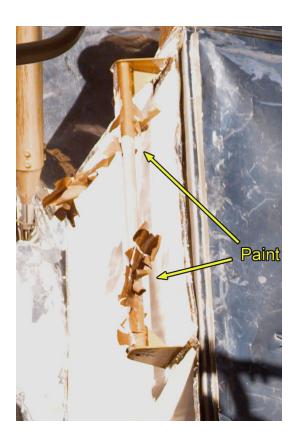
### Bay A handrail

SM-3A SM-3B

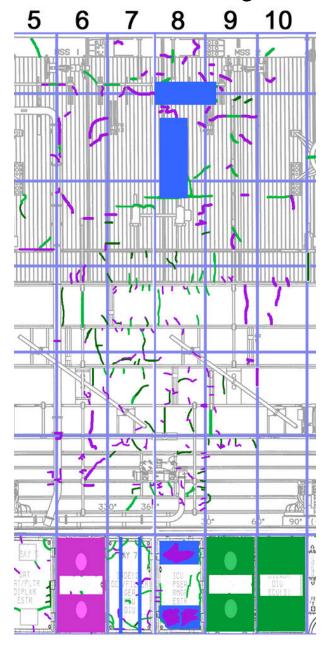
#### +V3 MLI damage

- 109 New damage site identifications
- 38 old damage sites grew larger
- Majority of new damage on +V3 in areas not well imaged on SM-3A.

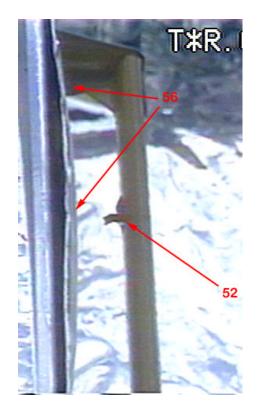
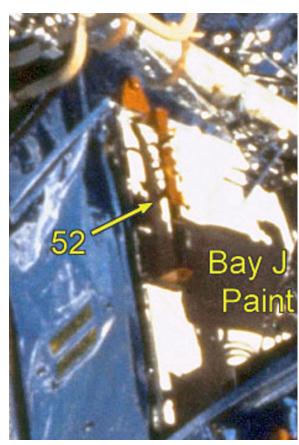
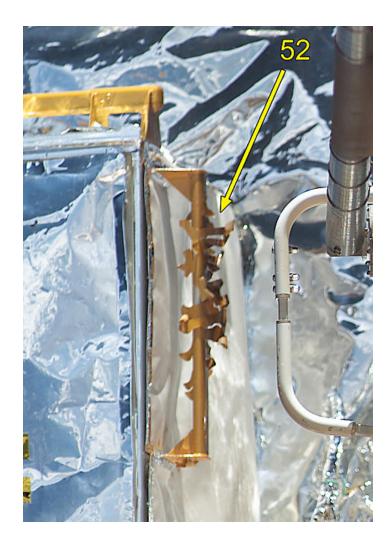
Bay J Handrail

SM-2 SM-3A

SM-3B

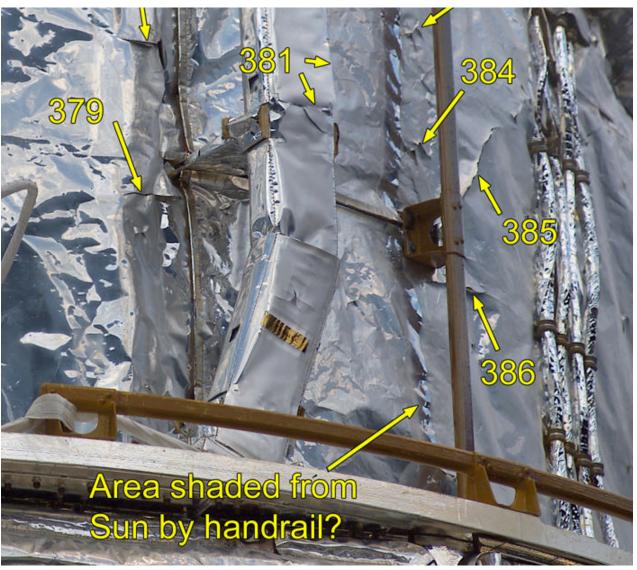
#### Sun Shaded area of MLI?

More likely a plume contamination causes haziness over time
