## HST SM-3B

Hingepin Survey
MLI Survey
Reboost HST Motion Analysis

David R. Bretz
Image Science and Analysis Group
JSC/SX3

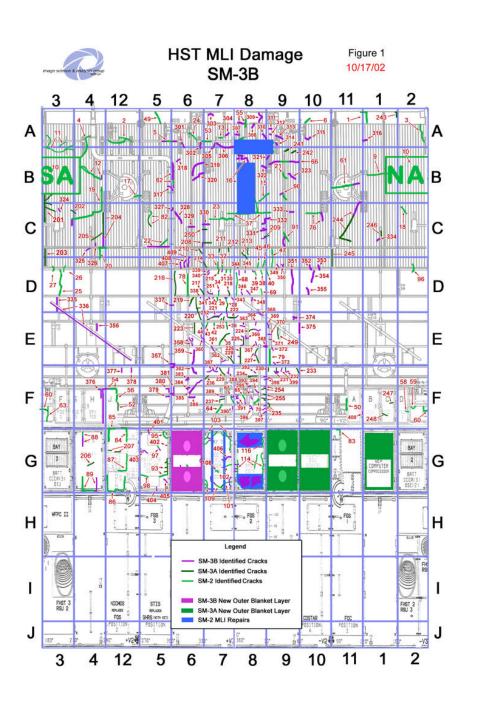
#### +V3 MLI damage

- 109 New damage site identifications
- 38 old damage sites grew larger
- Majority of new damage on +V3 in areas not well imaged on SM-3A.

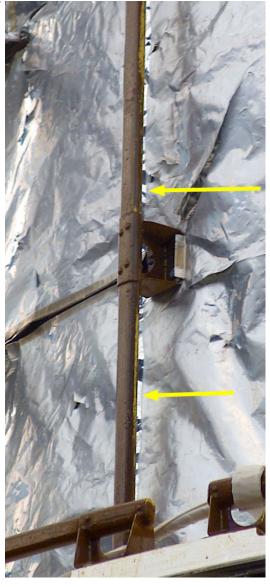
From +V3 fwd

#### Sun Shaded area of MLI?

More likely a plume contamination causes haziness over time

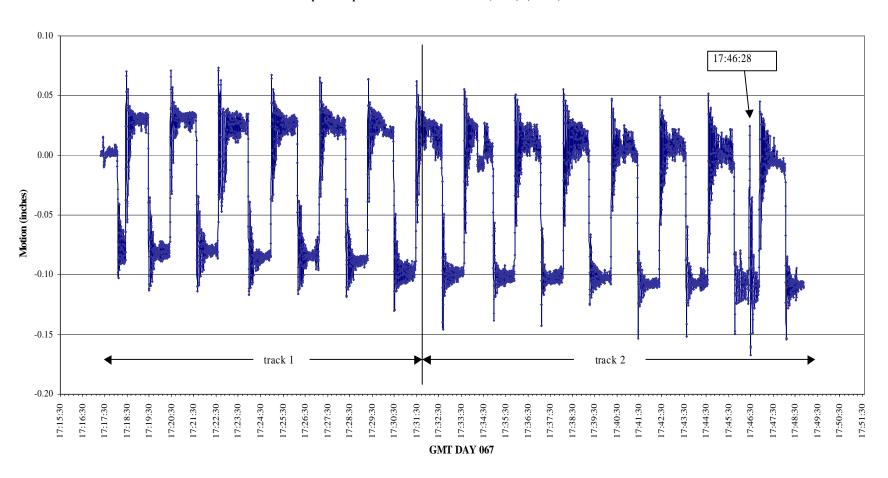
#### Reboost 1st Analysis on two movies

STS-109 HST SM-3B Reboost

Motion of +V2 Trunnion

Motion is in positive pivot direction vector XYZ =(0.968, 0, 0.252) orbiter coordinates

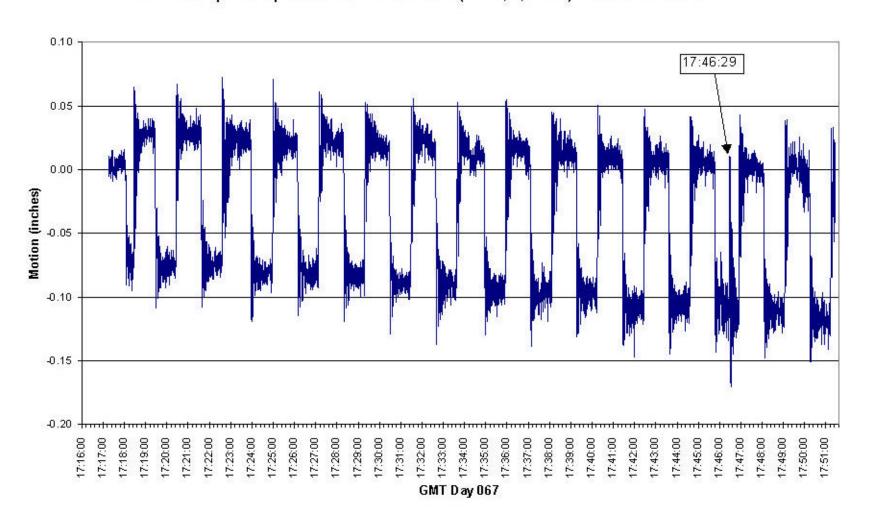
#### HST Motion during Gimbal Event (water dump)

STS-109 HST SM-3B Reboost

Motion of +V2 Trunnion. Analysis is from a single continuous movie.

Motion is in positive pivot direction vector XYZ = (0.968, 0, 0.252) orbiter coordinates.

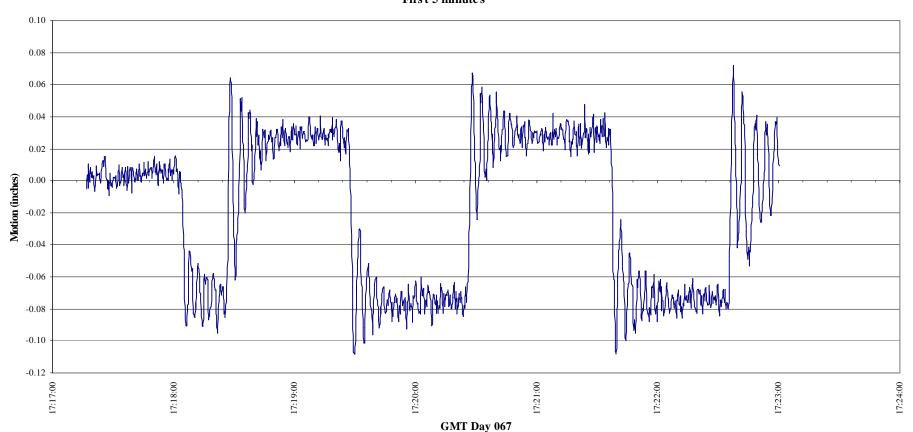
# HST Reboost Motion in the first 5 minutes More compressed movie More noisy tracking

#### STS-109 HST SM-3B Reboost

Motion of +V2 Trunnion. Analysis is from a single continuous movie. Motion is in positive pivot direction vector  $XYZ = (0.968, \, 0, \, 0.252)$  orbiter coordinates. First 5 minutes
